University Mohamed Khider of Biskra
Faculty of Architecture and Urban Planning
Department of Earth and Universe Sciences

MASTER THESIS

TPOLOGY OF DEGRADATION IN INDIVIDUAL HOUSINGS IN URBAN AREAS AND OPTIMAL INTERVENTION MEASURES "CASE STUDY OF THE CITY OF BISKRA "

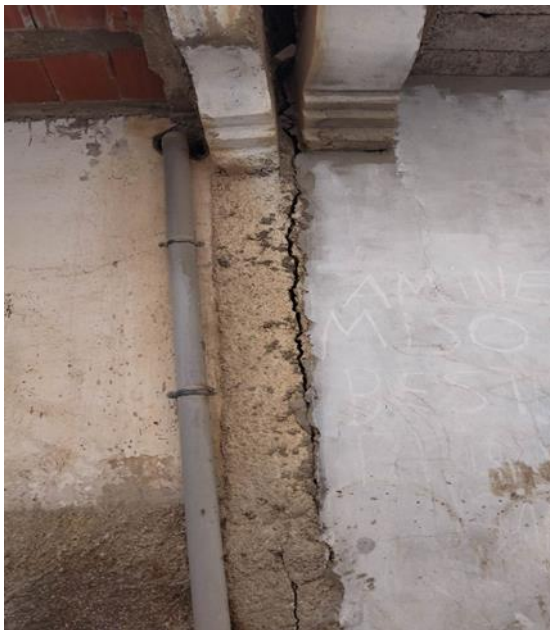
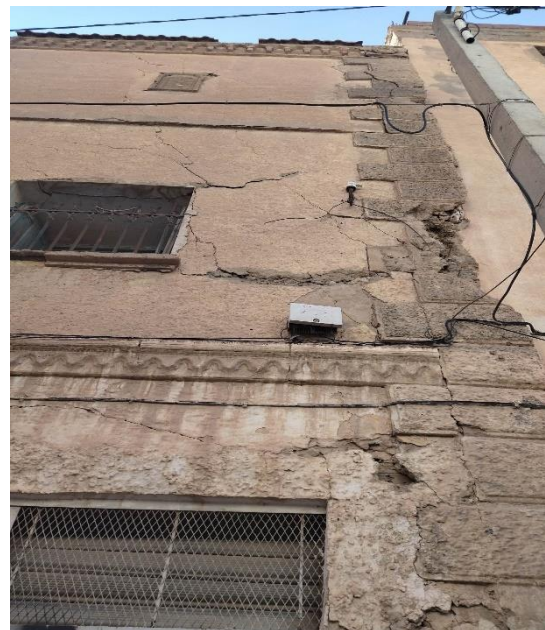
Figure2 Cracking and degradation of the exterior wall with the continuation of cracks to other parts of the house facade (Sitar Al-Muluk neighbourhood)

Figure3 Vertical crack at the level of the dividing column between the two residences (Bou Said neighbourhood)

The two figures (2) and (3) show structural cracks extending along the outer column of the residence, indicating a flaw in the foundation design or its unsuitability for the existing ground type. Figure 3) reveals that these cracks and fissures continue to include other parts of

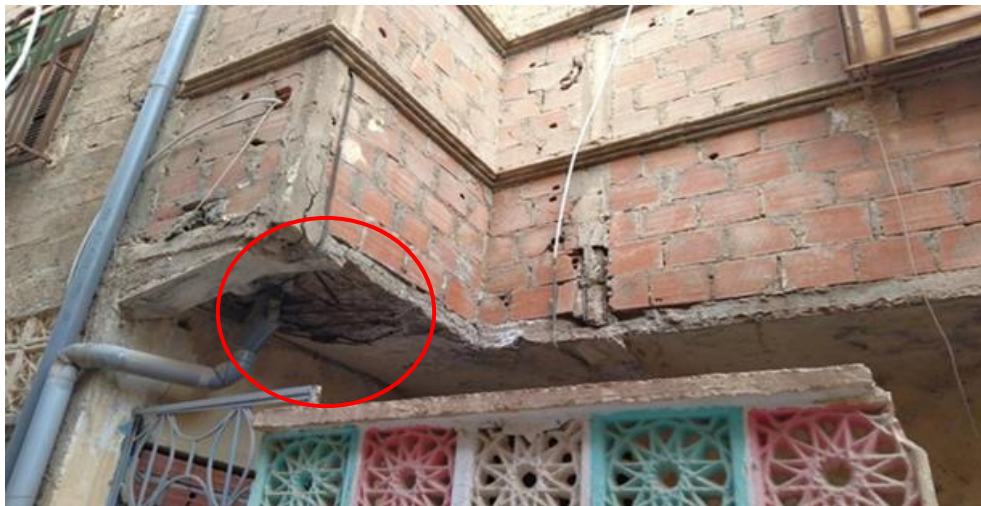
Figure4 Shows the degradation of the concrete due to the corrosion of the reinforcement steel (Al-Masla neighbourhood)

Figure 04 was taken from the Al-Masla neighbourhood, showing the collapse and breakage of concrete and the protrusion of steel on the first floor of a two-story residence. These issues are likely due to manufacturing defects or the use of poor-quality materials. Additionally, the photo shows the corrosion of steel materials due to the poorly installed gutter. Climatic conditions contributed to the interaction of moisture with the sun's heat, leading to the corrosion of the reinforcement steel. As rust developed, the bond between the steel and concrete was lost, causing noticeable peeling and breakage.

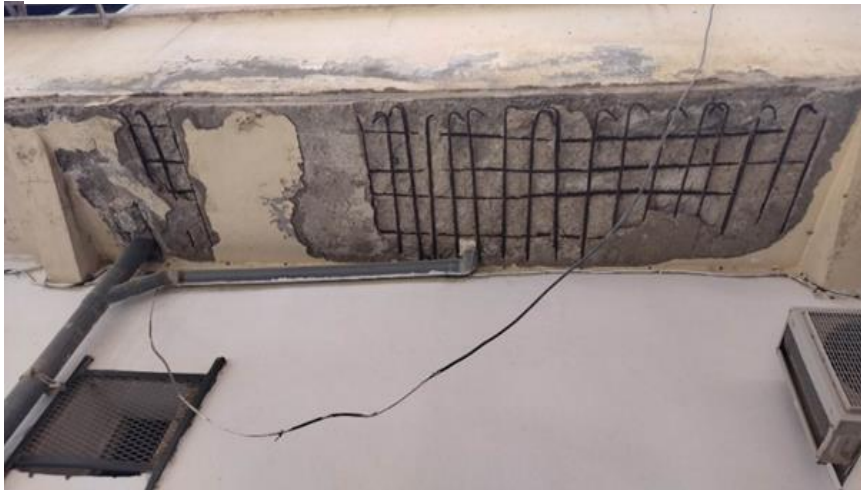
Due to water leaks and stagnation resulting from household activities. It is also probable that the residence did not adhere to construction and safety standards during its construction.

Figure5 shows a balcony on the verge of collapse in the Jnan Ben Yacoub neighbourhood.

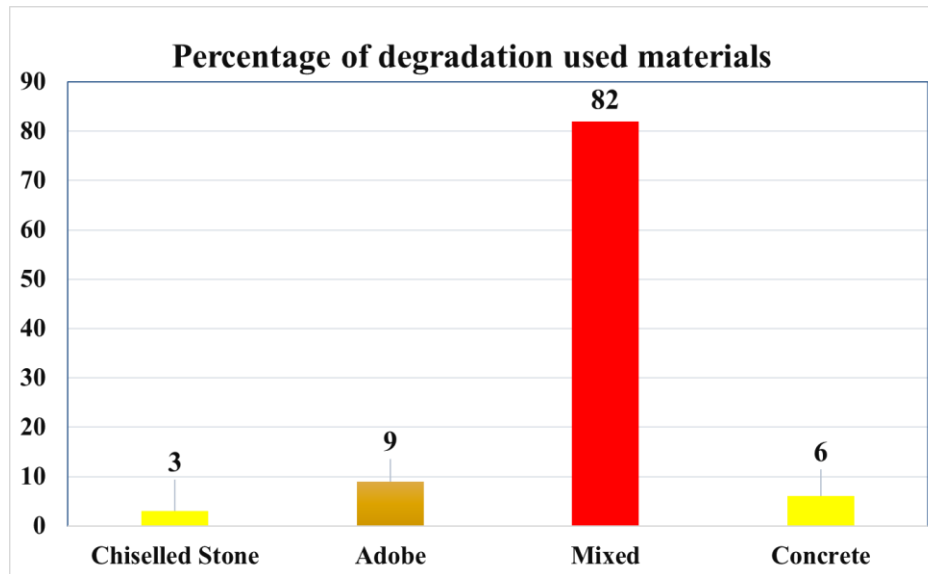
Figure6 A chart showing the deterioration of houses according to the building materials used.

Figure7 The rate of degradation according to the building materials used.

According to the data provided in Table 02, the rate at which different types of construction materials deteriorate varies greatly and is primarily determined by their composition, physical and chemical characteristics, and the environmental conditions to which they are exposed .

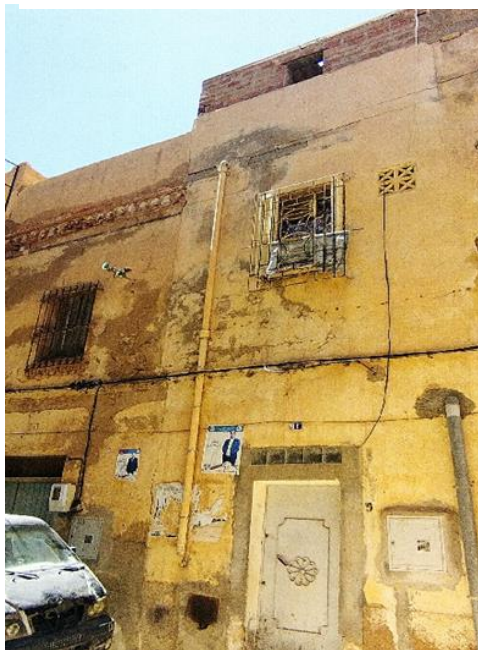
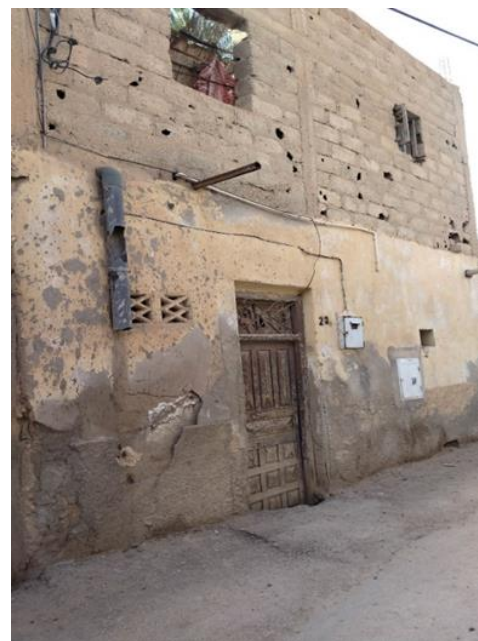
Figure 8 The paint damage due to lack of maintenance is evident in the Haret Al-Wad neighbourhood.

Figure 9 The degradation of the facade due to the ageing of materials in the Al-Masjid neighbourhood is evident.

The two figures (08) and (09) show the condition of two houses in the neighbourhoods of Biskra. Figure 08 highlights the clear effect of humidity on the wall of one of the houses. Humidity has caused the paint to peel and the wall surface to change colour, exposing the inner layers in the lower part of the house, which were continuously exposed to sunlight, rain, and wind. This could be a possible reason for the facade's degradation. It is also possible that the damage is due to moisture penetrating through the walls of the house or rising from groundwater. Similarly, Figure 09 illustrates damage to the exterior façade of another house caused by harsh weather conditions, including rain, humidity, and direct sunlight. These factors have significantly affected the condition of the facade. The degradation in both houses is primarily due to neglect and the lack of necessary regular maintenance, which has exacerbated the problems and accelerated the deterioration process.

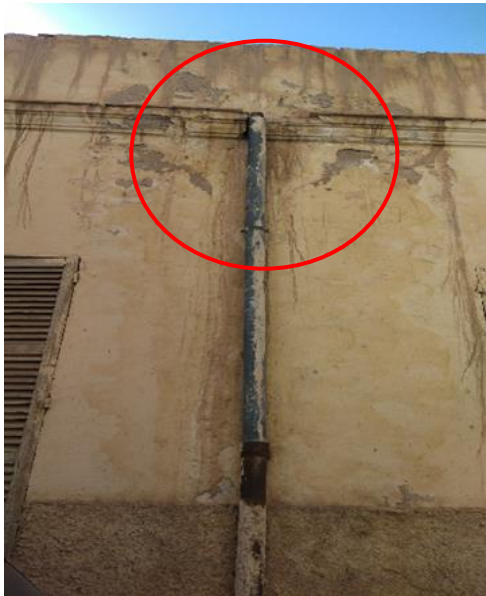
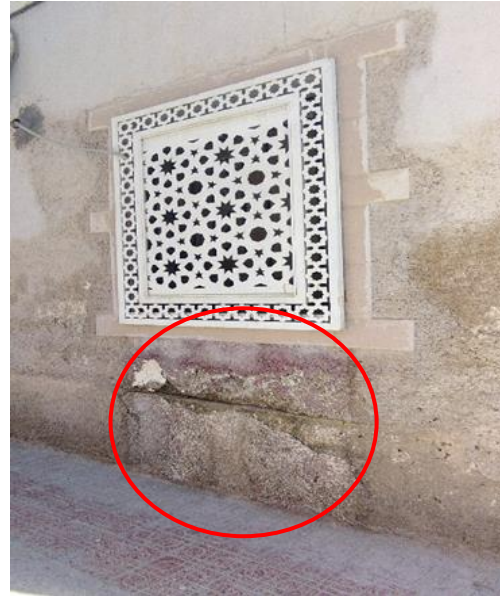
Figure8 Horizontal cracking, mould appearance, and paint deterioration (SAlmahatta neighbourhood)

Figure13 Peeling wall, rusted drainage pipes, and paint damage (Dalia neighbourhood)

Figures 12 and 13 of the station neighbourhood and the Dalia neighbourhood show the discoloration and damage to the wall paint, with colours leaning towards brown and yellow. The cause is likely, as shown in Figure 12, due to defects in the implementation of plumbing and sewage systems. This results in blockages in the gutters, leading to the leakage of surface and rainwater from the drainage pipes, in addition to the pipes rusting. All of this has contributed to the appearance of moisture along the pipe, leading to the erosion of the outer wall and the peeling of the paint. According to the American Society of Plumbing Engineers (ASPE), hydraulic design should include precise slopes to prevent water accumulation in the pipes.

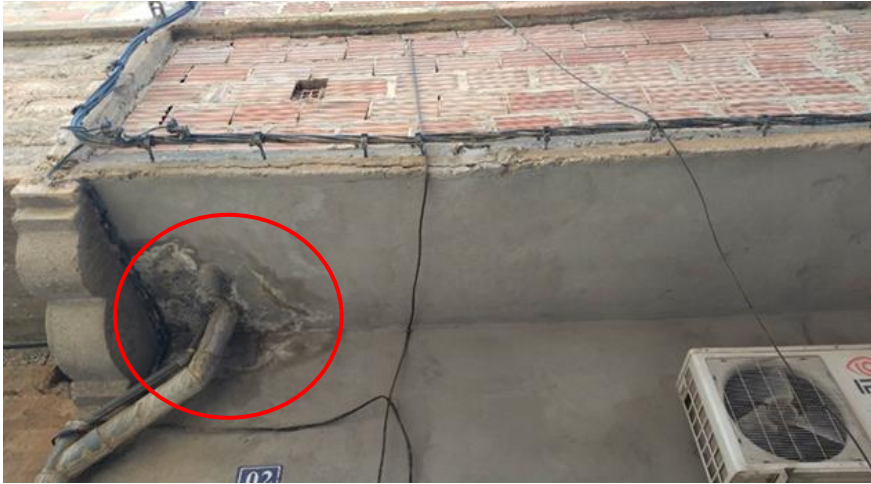
Moreover, moisture can arise from uncontrolled water due to pipe, gutter, and drain leaks. This is evident in Figure 14, where water has seeped into the rafters and balconies, resulting in unsightly water stains. Over a long period of moisture penetration and ventilation, the excess moisture has promoted mould growth on the sides of the columns and gutters.

Figure9 This figure shows the leaking sewage pipe and the mould that has grown around it in the Al-Dhala neighbourhood.

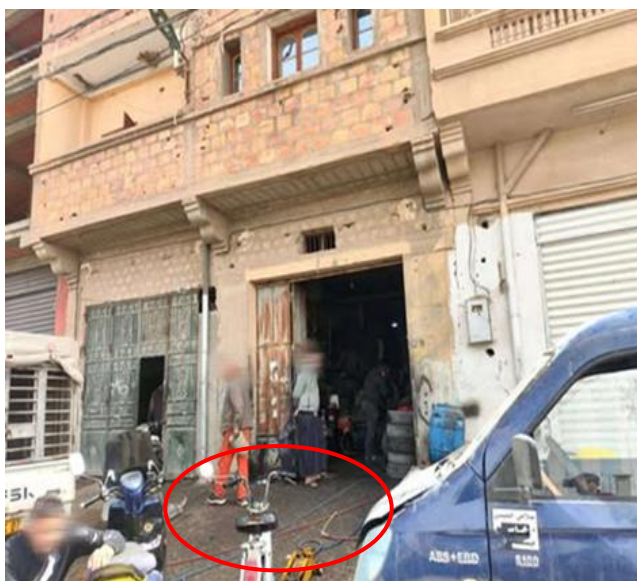
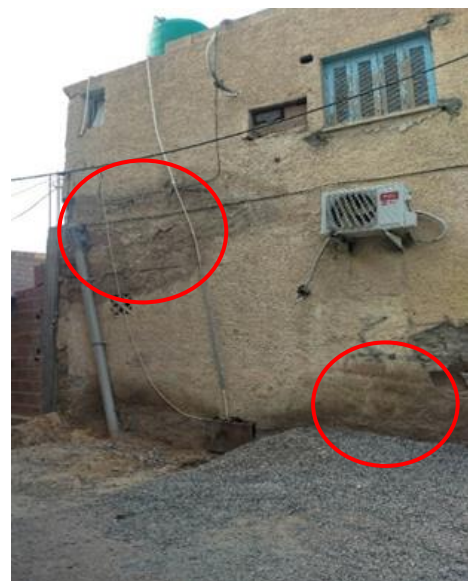
Figures 15 and 16 show the noticeable degradation in two types of buildings in the city of Biskra. In Figure 15, taken in the Bab al-Darb neighbourhood, we see mould marks on the facade of a building consisting of a ground floor and a first floor.

Figure10 A car repair workshop located beneath one of the houses in the Al-Bukhari neighbourhood.

Figure 16 Clear mould spots appearing on the exterior wall of a residence in the Bab Al-Darb neighbourhood.

There are clear water leaks, indicating gradual decay or wet rot affecting the walls due to a clogged sewage gutter. Signs of moisture were also observed at the bottom of the exterior wall, likely caused by saline groundwater that led to the erosion of the exterior plaster. Additionally, the improper installation of drainage pipes contributed to the increased humidity levels and mould formation. As for Figure 16, it shows a car repair workshop in the Bukhari neighbourhood, where the workshop floor is entirely black due to the chemicals and industrial substances used in car maintenance. Furthermore, the air and noise pollution resulting from the equipment reduces the lifespan of the dwelling over time.

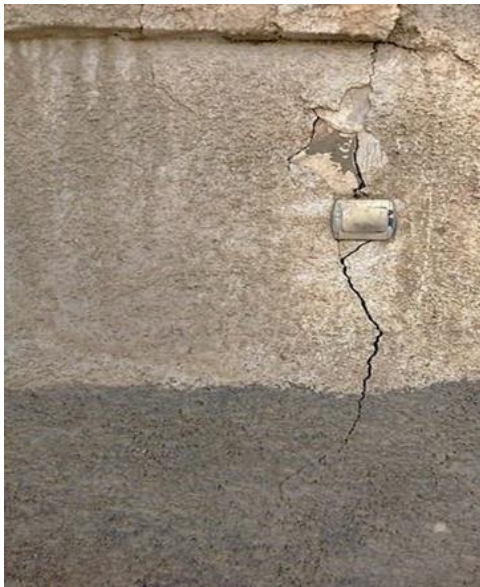
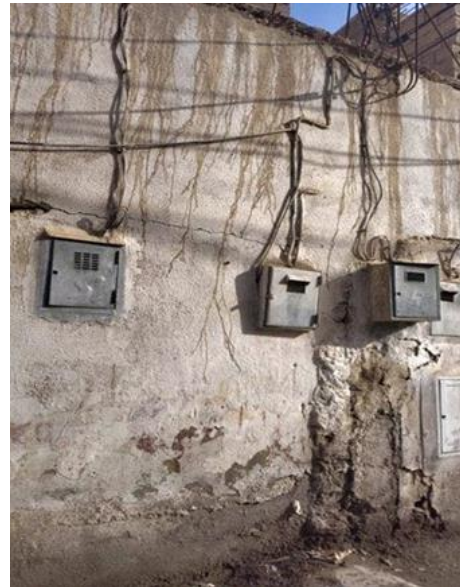
Figure12 Deformation in the installation of electrical equipment and the appearance of a horizontal crack in the external wall of the residence in the Khobzi neighbourhood.

Figure 20 Shows exposed electrical and gas wires and the degradation of the housing wall in the Al-Masid neighbourhood.

Several residences with electrical installation defects have been identified, as shown in the above photos. The existing potential for this hazard can lead to an electrical short circuit, exposing the residence to the risk of a fire outbreak. An IEEE report indicates that "failure to consider the distribution of electrical loads can lead to overheating and an increased likelihood of fires." The lack of maintenance, or rather the absence of it, leads to the deterioration of the residence and its inability to perform its function throughout its lifespan.
